# AUTOMOTIVE / VARIOUS MANUFACTURER

## CONVEYER SUBSTRUCTURES

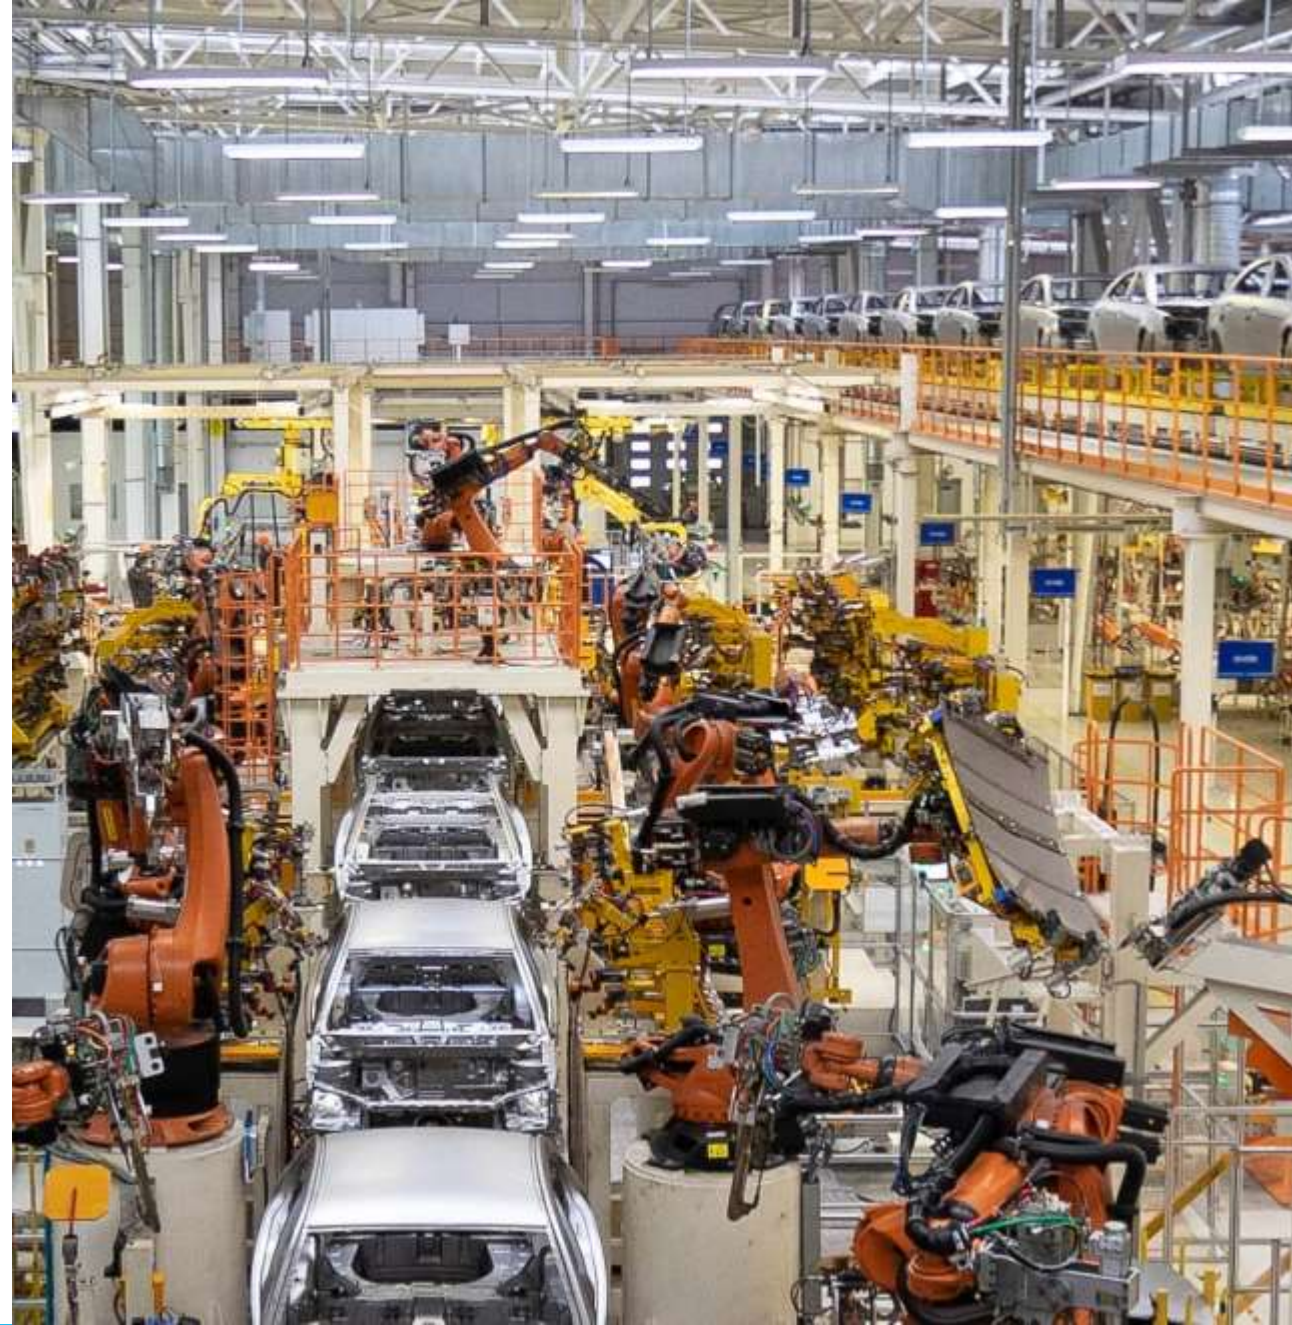
Vibrations in conveyor technology are obvious. Building owners hire companies to regularly retighten the connections. The costs for this are immense.

In most cases, the investment in Nord-Lock has already paid off after one year, as there is less to check and nothing to retighten.

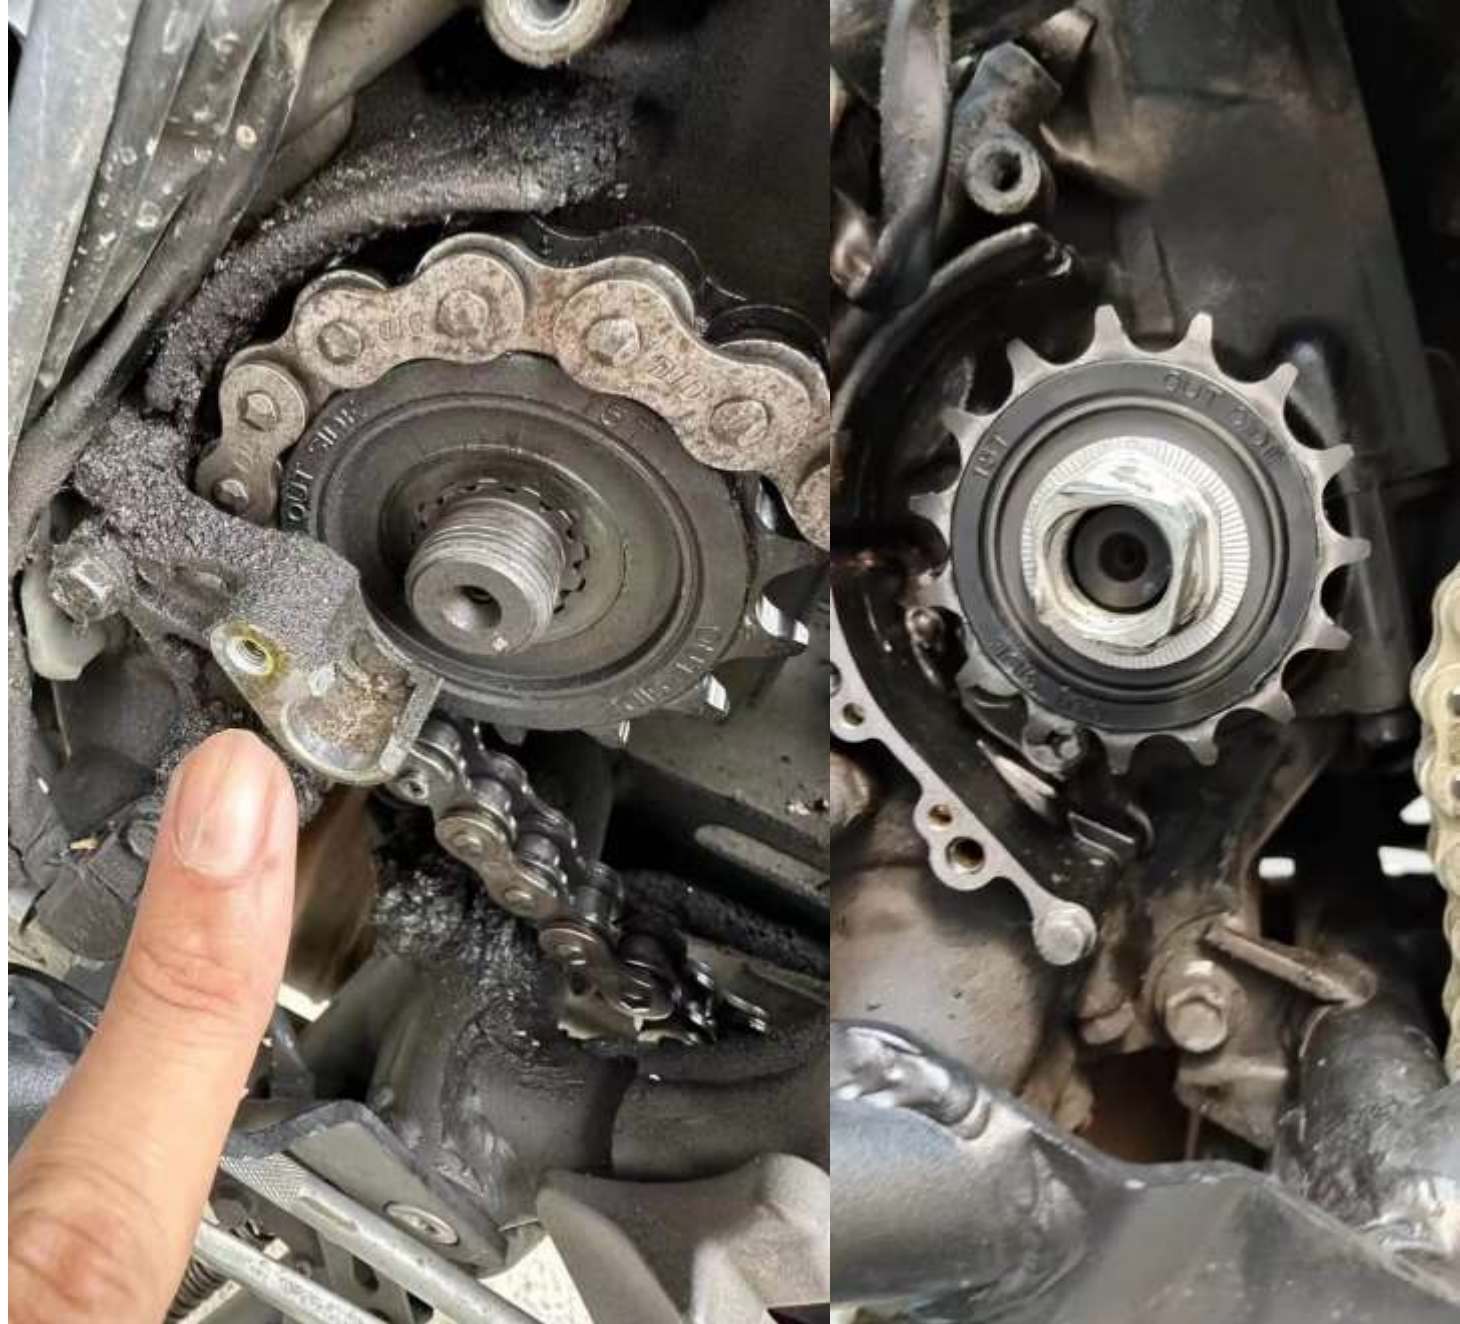
An existing NL customer who likes riding motorcycle, discovered that the flange nut covering the inner flywheel of his motorcycle consistently loosens and sometimes even comes off due to the high rotation speed of the output shaft. This issue has led to damage to the encoder bracket, a common occurrence among motorcycle enthusiasts.

The customer used NL24sp and they has never loosened after installation.

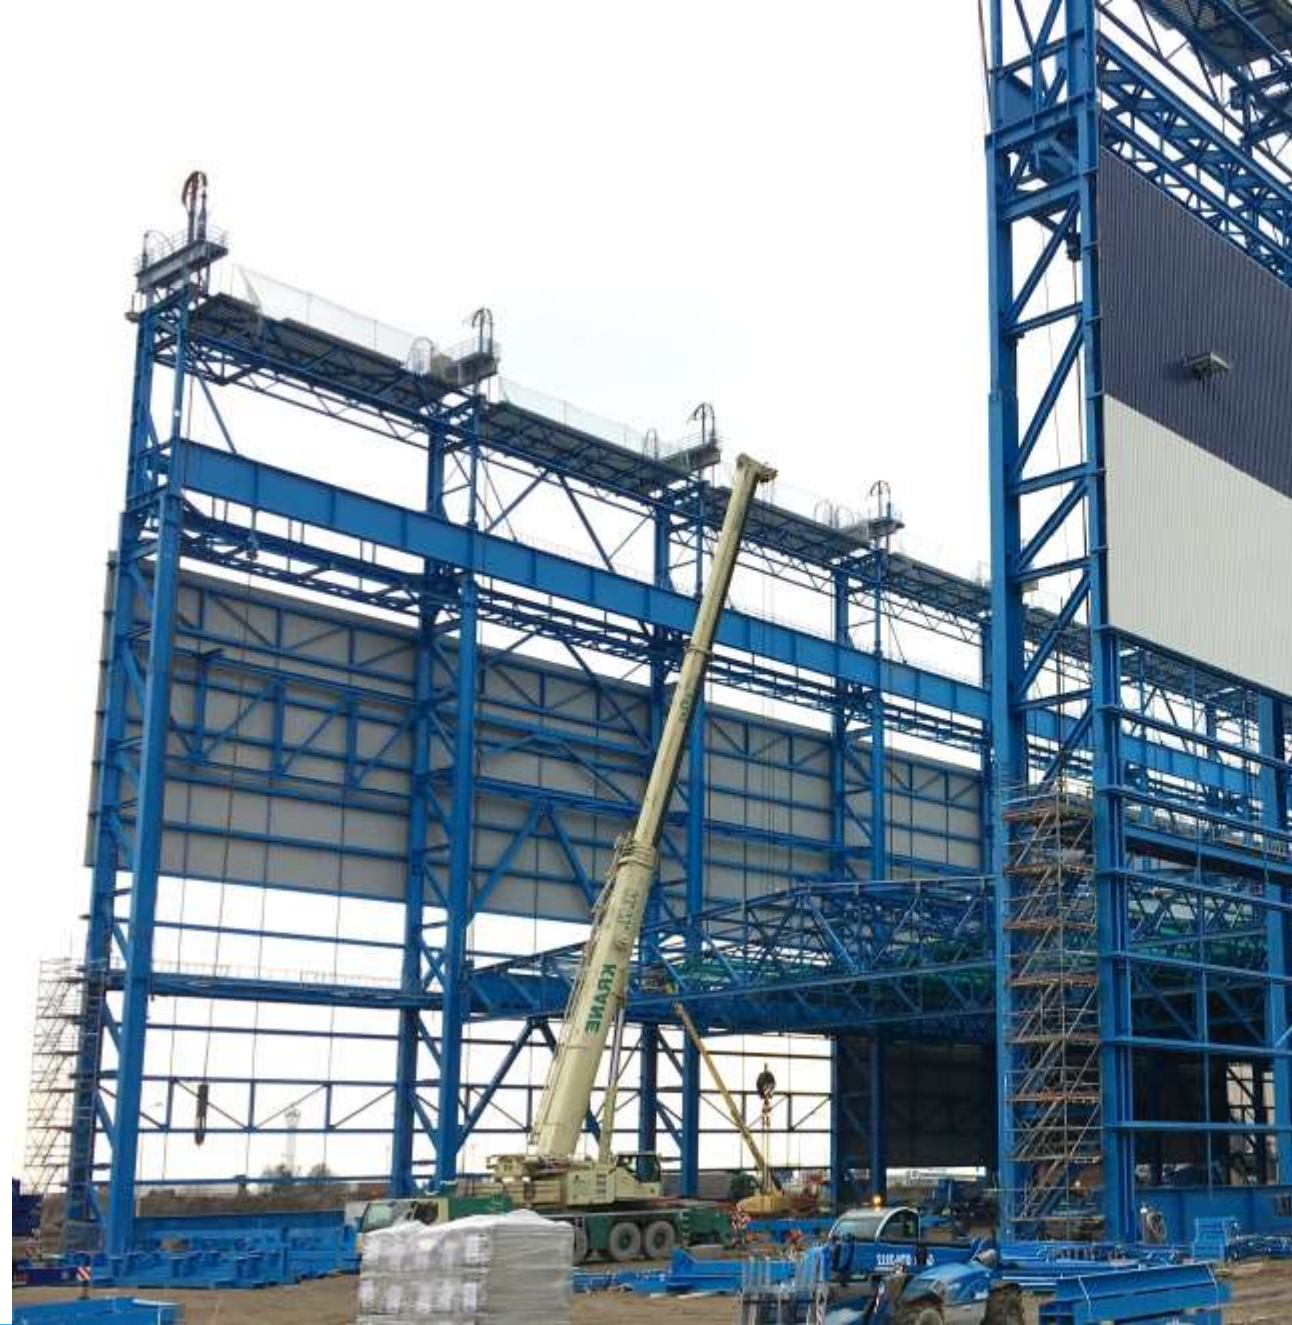
Heavy crane operation, high loads, strong winds near the coast, have made us wonder if the bolted connections might come loose. Maintenance of the bolted connections at >60 m is very difficult.

The majority of the bolts were larger than M24. Mainly HV assemblies according to EN 14399-4 were used. These were secured with Nord-Lock SC washers.

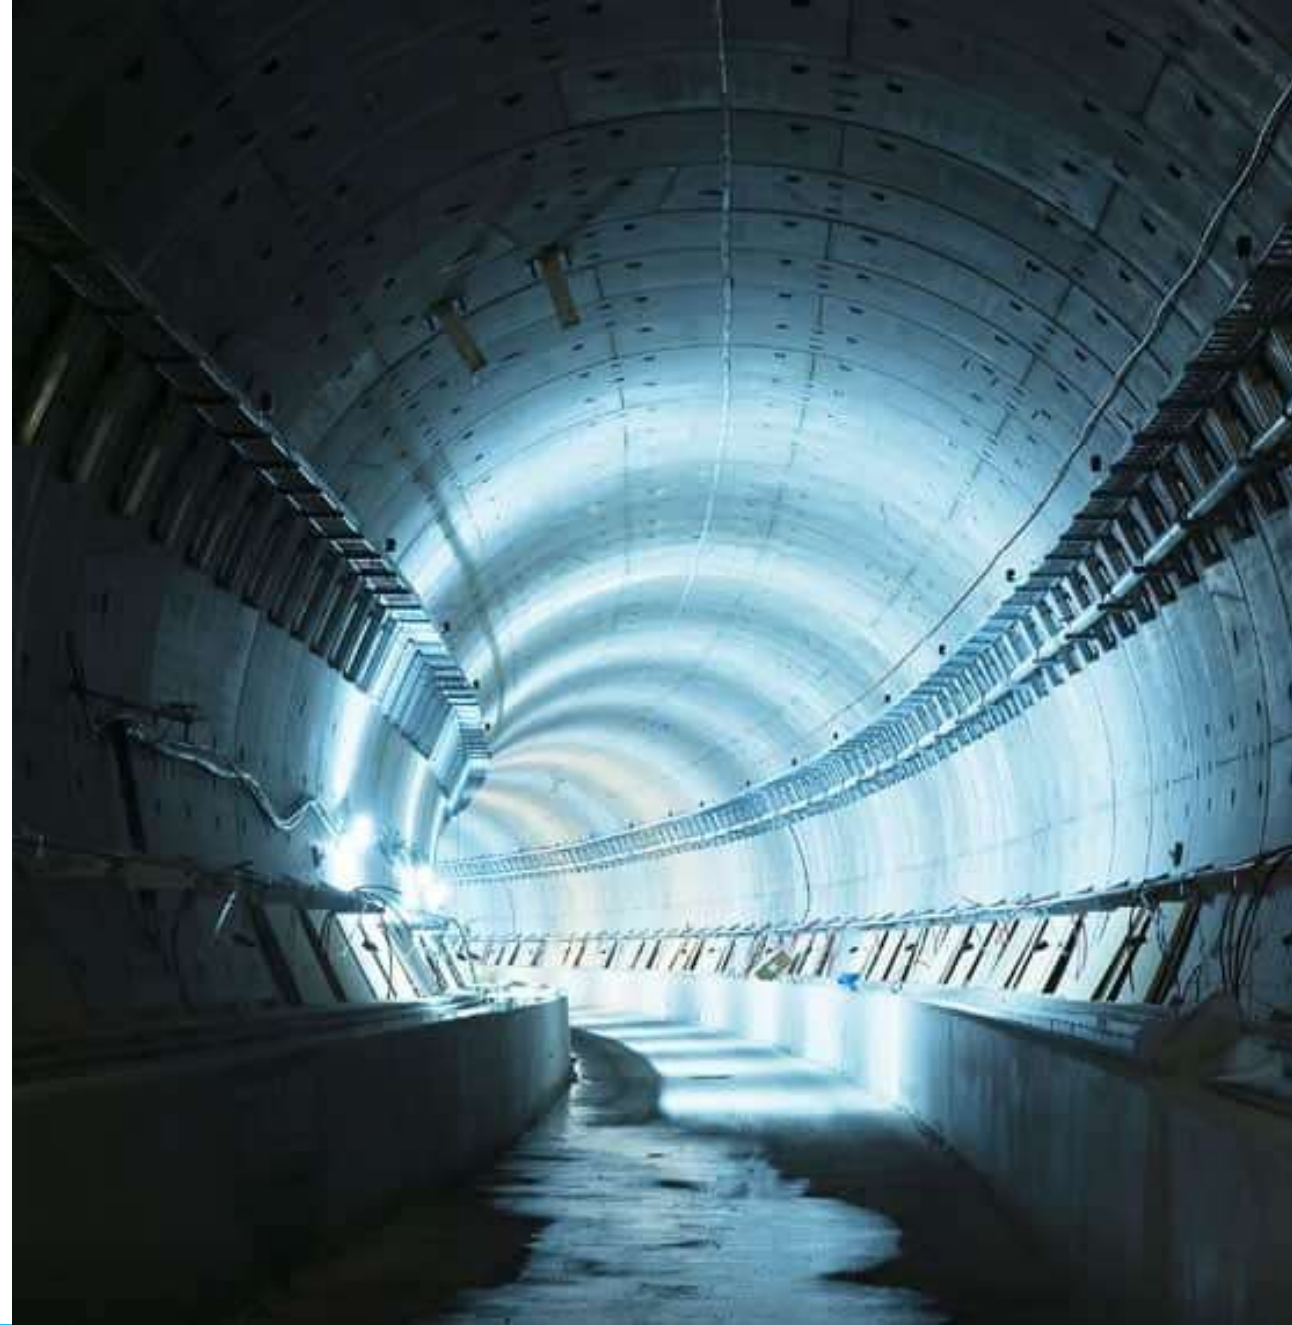
Contractor NCC, responsible for the underground station and platform, was tasked with finding a solution that would keep the gantry firmly bolted to the tunnel's roof and able to resist the pressure waves created by trains entering and leaving the station.

The answer was a series of steel rails cast into the concrete of the tunnel roof. Into these rails are secured thousands of anchor bolts manufactured by Halfen-Deha in top-quality A5 steel, each of which is secured with a Nord-Lock washer pair.
